2. Site Conditions

The Sites

This section provides an overview of the three specific sites being considered in the North Lake Union Master Plan. Sites are treated individually as each has unique conditions and features. Basic site information is provided for 1.) the Upland Parcel, 2.) the Waterfront Parcel and 3.) the Stone Way Pier.

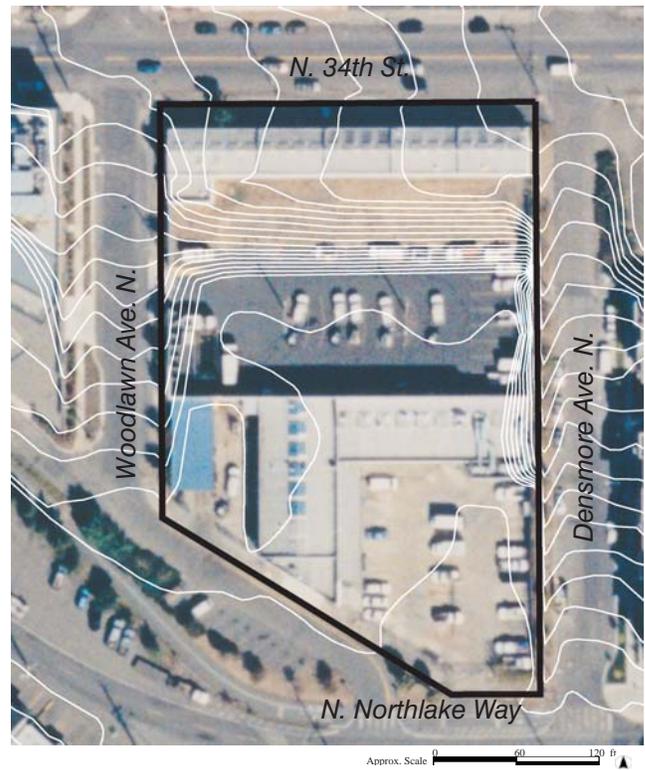
Natural Features

- Significantly sloped from the north to the south
- Northeast corner elevation of roughly 56',
- Southeast corner elevation roughly 20'
- 36' total grade change
- Steep embankments stretching across middle of site below building A
- Steep embankments along streetedge of Woodlawn Ave. N., and Densmore Ave. N.
- Embankments artificially created by cut
- No significant vegetation or other natural features on site

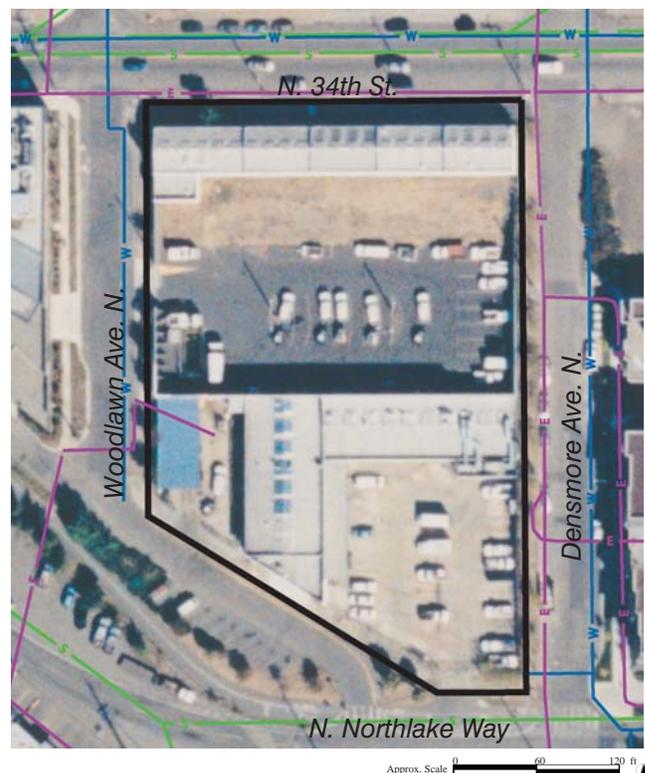
Infrastructure

- *Water:* Adjacent water lines in Woodlawn Ave. , Densmore Ave., and N. 34th St.
- *Electrical Service:* Adjacent Seattle City Light Lines in N. 34th St., Densmore Ave., and connection to site from N. Northlake Way at the southwest
- *Storm / Sewer Drainage:* Combined sewer / storm drainage main lines in N. 34th St., and in N. Northlake Way

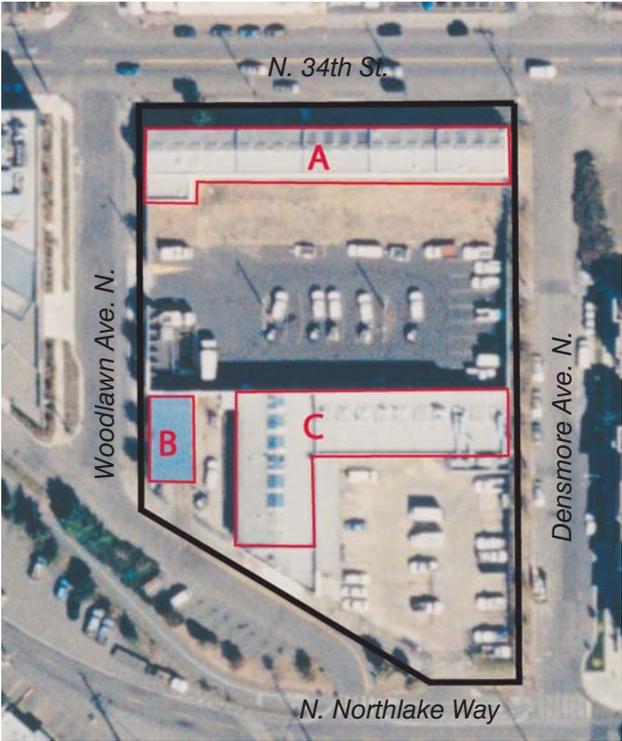
Existing Structures

- Three structures totaling roughly 19,000 Gross Floor Area on site
- Building A: One-story garage structure fronting on N. 34th St. Masonry. Originally constructed 1920s.
- Building B: An accessory garage storage structure. Masonry. Originally constructed 1920s
- Building C: Primary building. An L-shaped one-story warehouse and office structure. Originally constructed 1920s

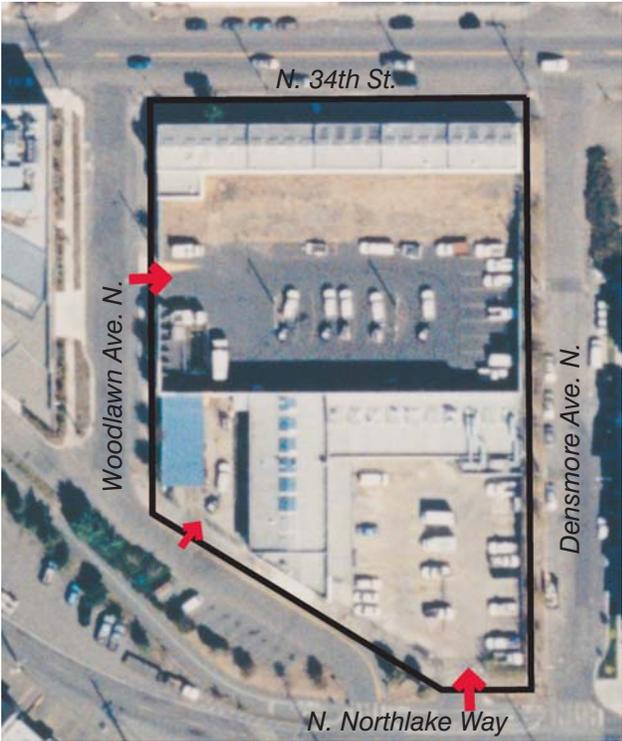
Site Access

- Vehicular site access at southeast edge of the site from N. Northlake Way
- Vehicular site access at east edge of site along Woodlawn Ave
- Secondary vehicular access point from N. Northlake Place at southwest edge of site to storage areas
- No clearly defined pedestrian access point, as bulk of entry to site is vehicular

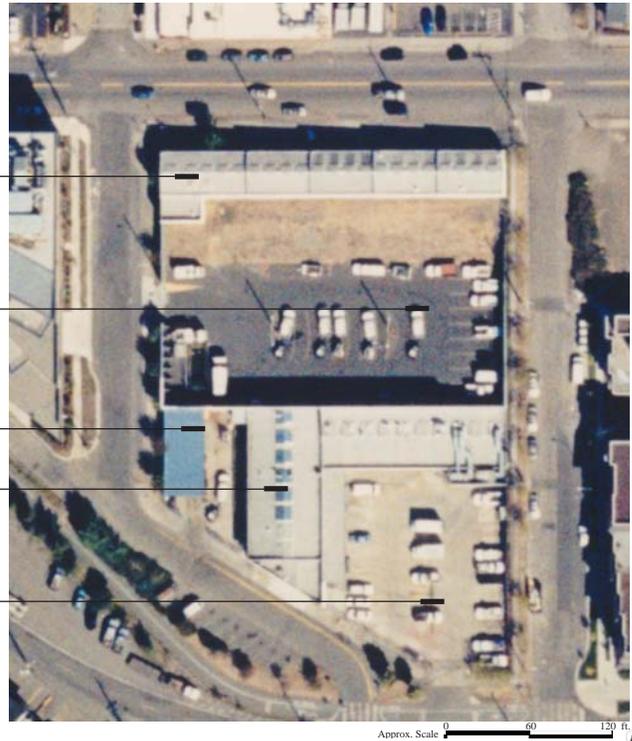
Current Functions

*Garage Building:
Currently used for
storage and work area.*

*Maintenance vehicle
and equipment storage
area.*

*Main Building: Admin.,
office, crew, and shop
spaces.*

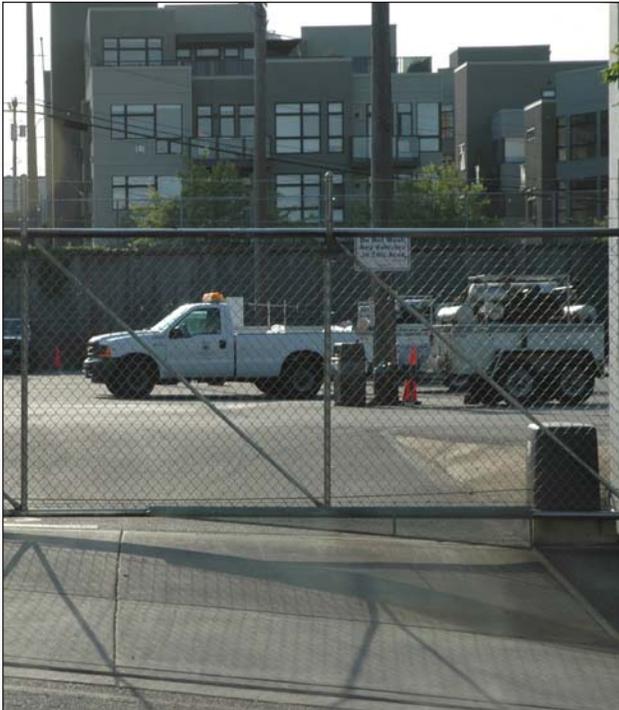
Current functions - Maintenance vehicle / equipment parking on the Upland parcel

The types of spaces and equipment needed to perform the full King County METRO functions are summarized below. These spaces / equipment are currently all located on the North Lake Union upland parcel.

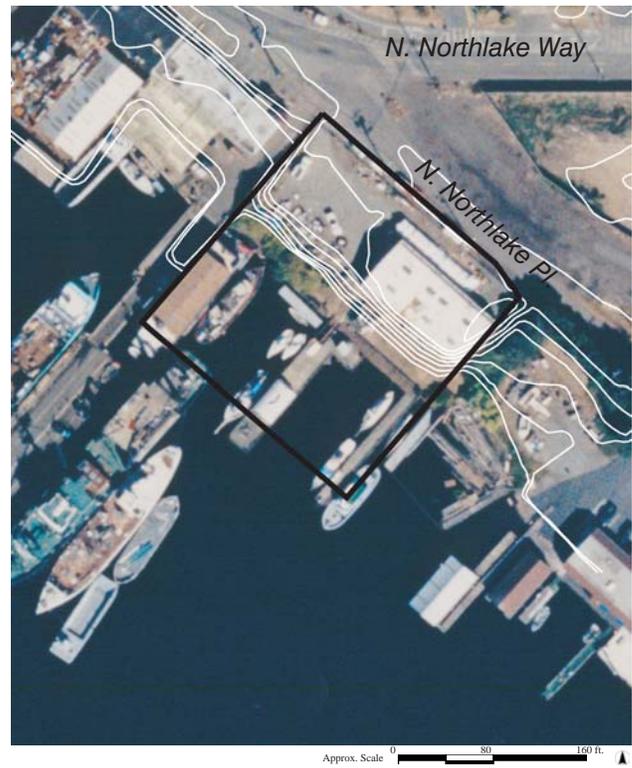
Natural Features

- Significant portion of site is submerged. Roughly 30,550 sf. dry land and roughly 25,948 sf submerged area.
- Gently sloped from site's northeast border to the water's edge. Majority of slope is directly adjacent to water.
- Most of waterfront occupied by bulkheads and docks.
- Entire site encumbered by Shoreline Master Program policies and regulations. (See *Code & Regulatory Framework*.)

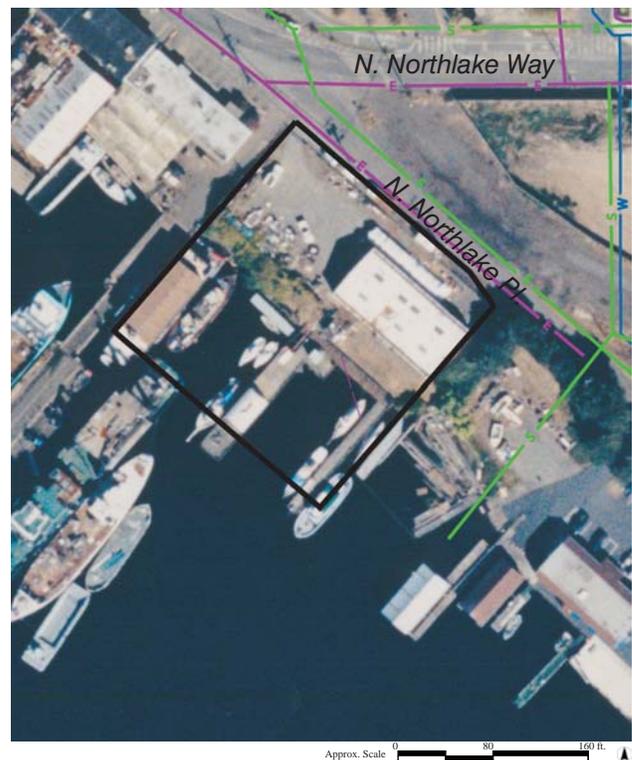
Infrastructure

- *Water:* Nearest water line extends south from Densmore Ave. through the Seattle-owned parcel.
- *Electrical Service:* Adjacent Seattle City Light line runs adjacent to the site along the north eastern edge.
- *Storm / Sewer Drainage:* Combined sewer / storm drainage main line runs along the site's northeastern edge in N. Northlake Place. An overflow outfall discharges to North Lake Union in the Waterway #20.

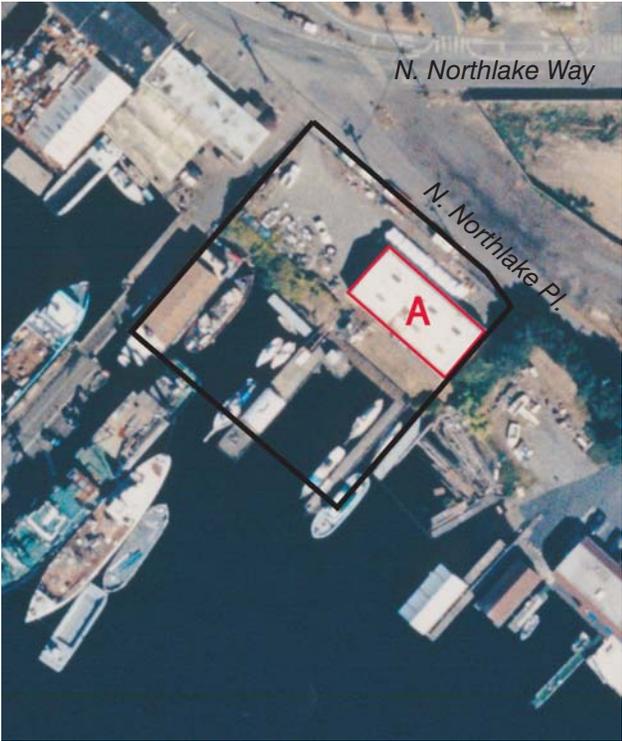
Existing Structures

- Building A: Only building structure on site. Warehouse / storage building. Wood frame. In poor condition. Originally constructed as early as the 1930s.
- Docks: Several dock structures extend from the site into Lake Union. Two smaller docks extend from the southern half of the site. The condition of these docks is reported to be fair to poor. No major upgrade to the docks has occurred during Metro tenure of the site.

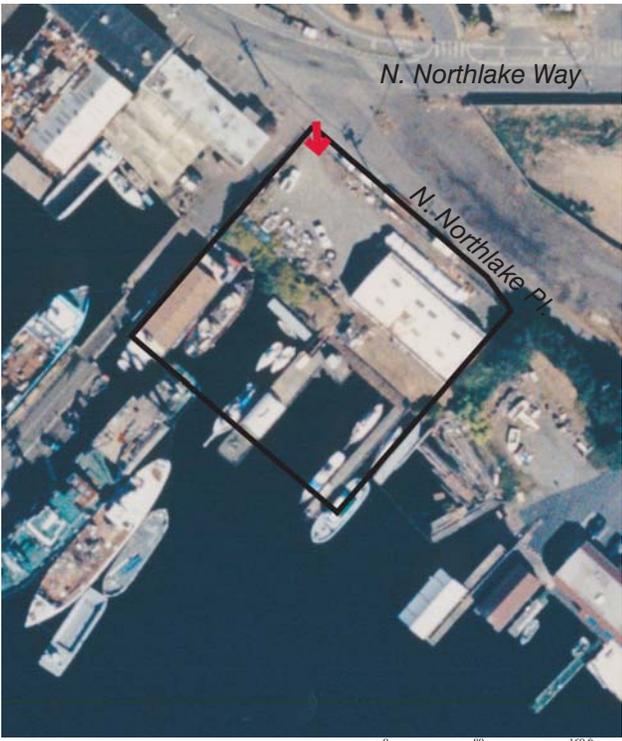
Site Access

- Primary vehicular site access is from the north west corner of the site from N. Northlake Place.
- By the Seattle Zoning Code Urban Maritime Overlay provision (see Chapter 4), public access must be provided to all sites under public ownership. No clearly demarcated public access way is provided at the current time.

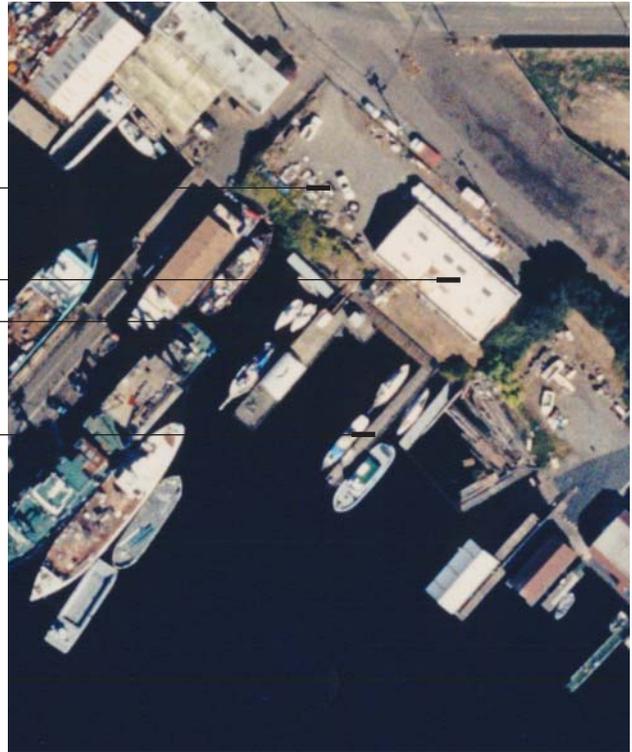
Parking. Open work area, small boat repairs.

Storage for Metro Facilities Maintenance.

Docking of boats - Schooner Society.

Schooner Society small boat docking.

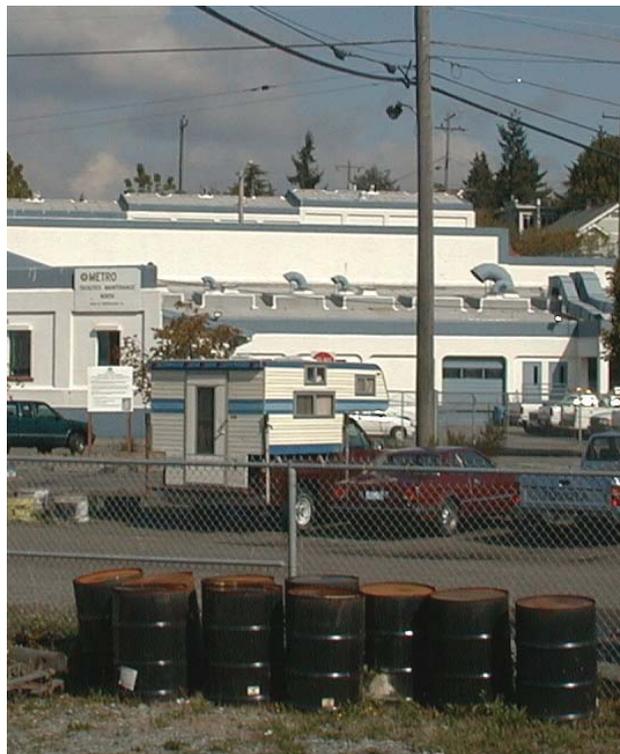
Photo taken before completion of cleanup. Upland parcel in background

Deeper soil contamination due to petroleum seepage required more extensive cleanup. More than 30 monitoring wells were installed on the upland and lowland sites to test for groundwater quality and contaminants ranging from benzene and toluene to hydrocarbons (PAHs) and dissolved arsenic and lead. (Figure pg. 17 shows location of groundwater wells). Where contaminants were found, cleanup measures were taken including:

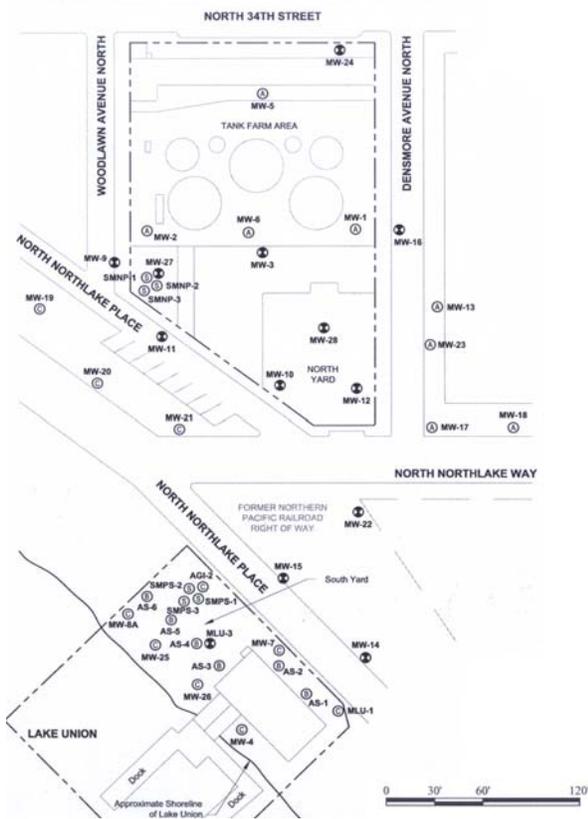
Locations of groundwater monitoring wells.

Cleanup of deeper soils and groundwater is now estimated to be 99% complete. As of April, 2004 only 6 wells continued to register low levels of contaminate (Separate Phase Hydrocarbon SPH). The location of these wells is on the south half of the upland site, and in public ROWs between the sites. Generally, these are areas where petroleum trucks had been fueled for many years.

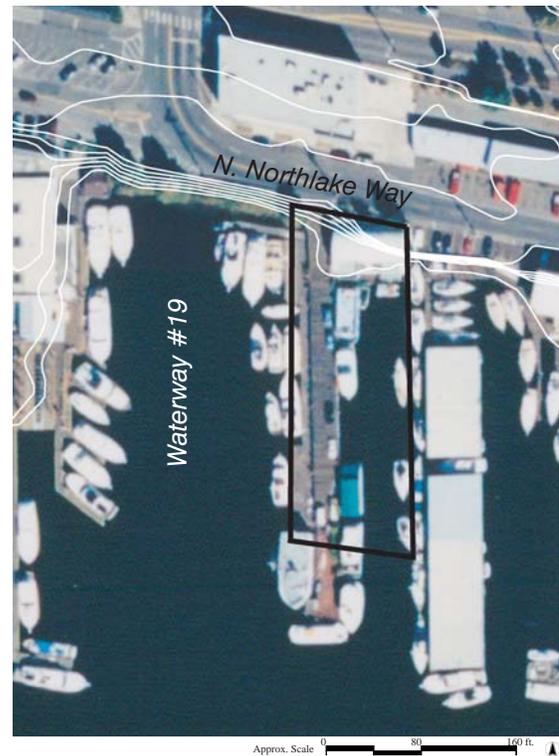
Natural Features

- Significant portion of site is submerged. Roughly 5,600 sf dry land, and roughly 21,269 sf submerged area.
- Gently sloped from site's north border to the water's edge. Bulk of slope is directly adjacent to water.
- Naturally vegetated waterfront edge immediately west of the site in public waterway #19.
- Entire site encumbered by Shoreline Master Program policies and regulations. (See *Code & Regulatory Framework*.)

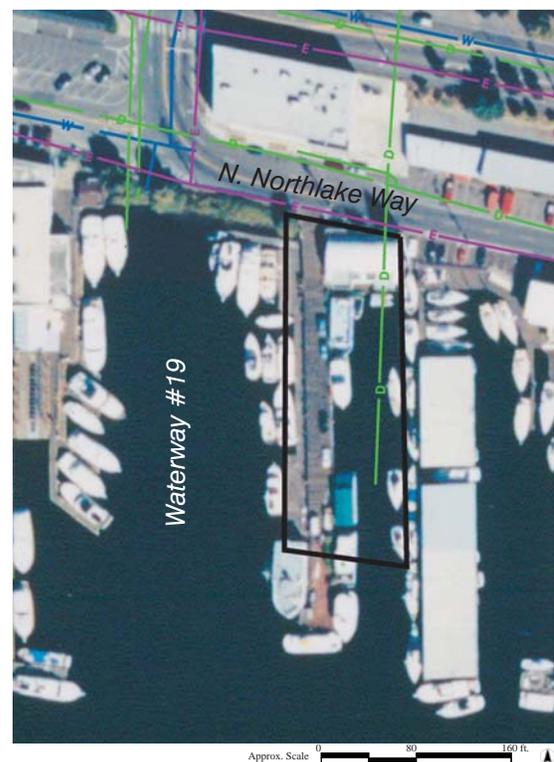
Infrastructure

- *Water:* Water line extends immediately north of the site along N. Northlake Way.
- *Electrical Service:* Adjacent Seattle City Light line runs along the sites northern edge in N. Northlake Way.
- *Storm / Sewer Drainage:* A combined storm / sewer drainage main lines run along Stone Way, N. Northlake Place. A drainage line also runs through the site and discharges during storm events into North Lake Union within the submerged portion of the site. This outfall may contain stormwater drainage from the transfer station which is just one block north of the site.

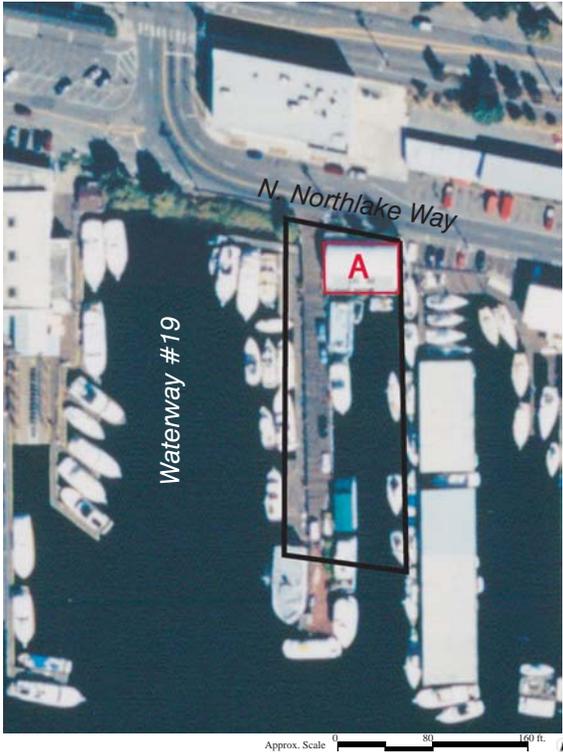
Existing Structures

- Building A: Only building structure on site. Woodframe retail and Marina building. In moderate condition. Commonly referred to as the “Quonset Hut”. Potentially holds some historic significance.
- Docks: One principal pier extends into North Lake Union. Pier has received significant private investment by tenant during the last decade. Pier is in good condition for heavy docking.

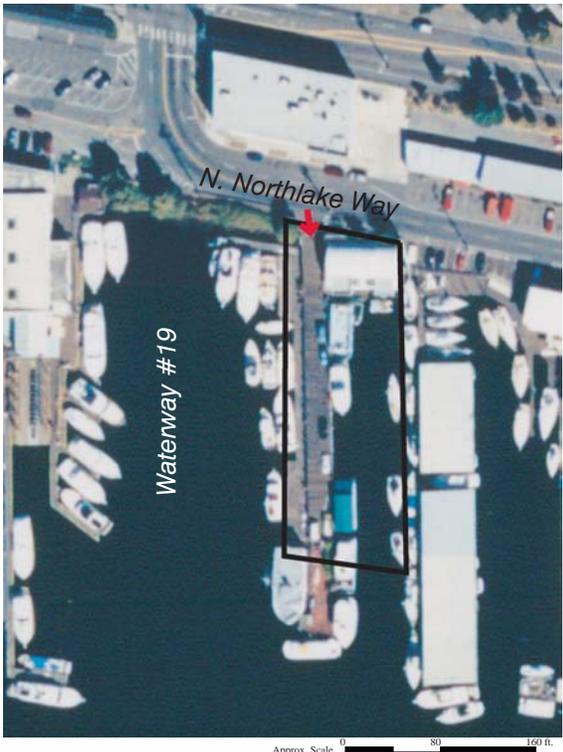
Site Access

- Primary vehicular site access is from the northwest via N. Northlake Way.
- Parking Shortage: Currently there is no legal space for parking of vehicles. By code, vehicles may not park on a dock structure over water.

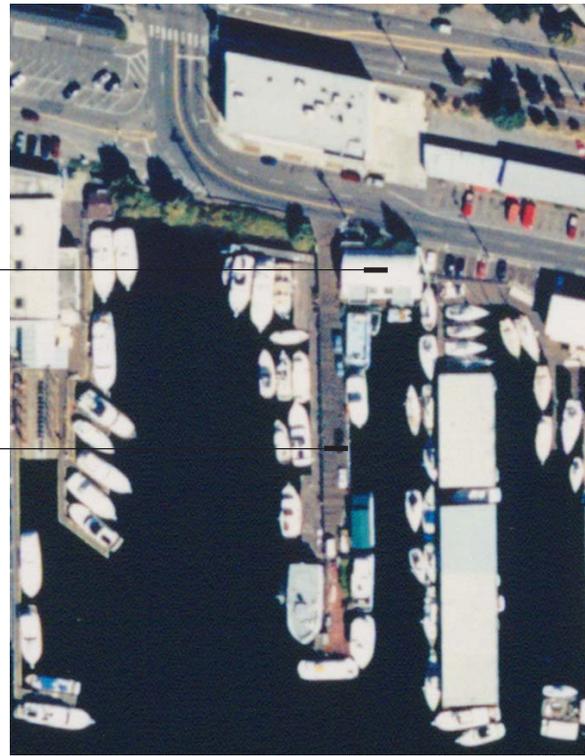
Commercial convenience market, and marine related offices.

Privately operated marina-related business. Docking of recreational boats.

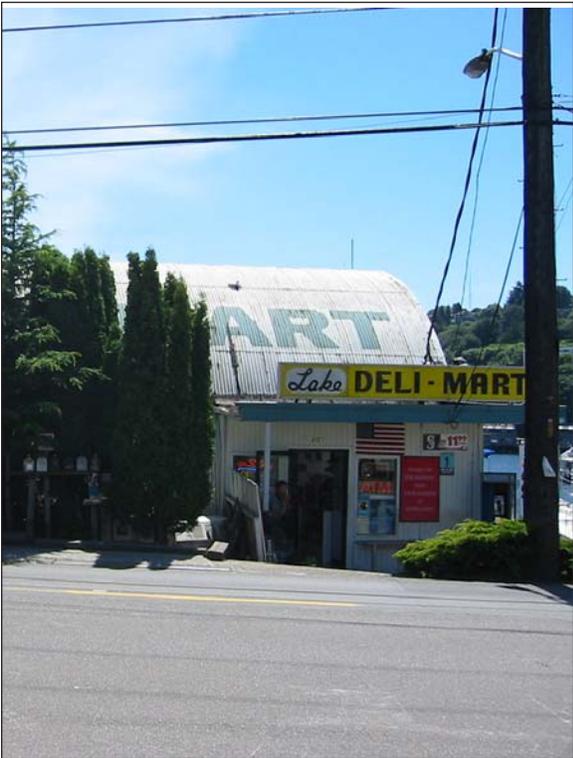
Existing structure on Stone Way Pier site - shows limited uplands for parking or dropoff
